Software Maintenance Release Note

Maintenance Version 291-19

for AR415S, AR440S, AR441S, AR442S, AR450S, AR725, AR745, AR750S, AR750S-DP, and AR770S routers and AT-8600, AT-8700XL, Rapier i, Rapier w, AT-8800, AT-8900, x900-48, AT-9900, and AT-9800 Series switches

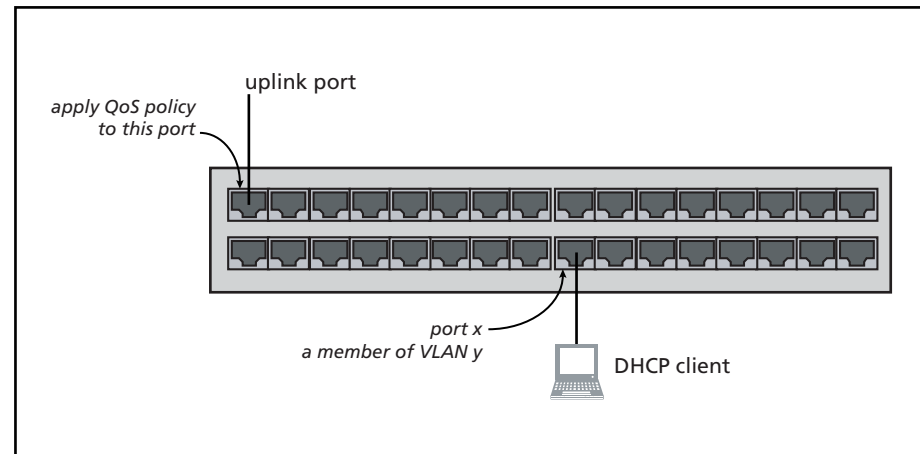
```
create classifier=1 ip=dhcp Snooping snoopport=x snoopvlan=y
```

When the client receives a DHCP lease, all traffic that comes in through the uplink port and is destined for the client will match classifier 1.

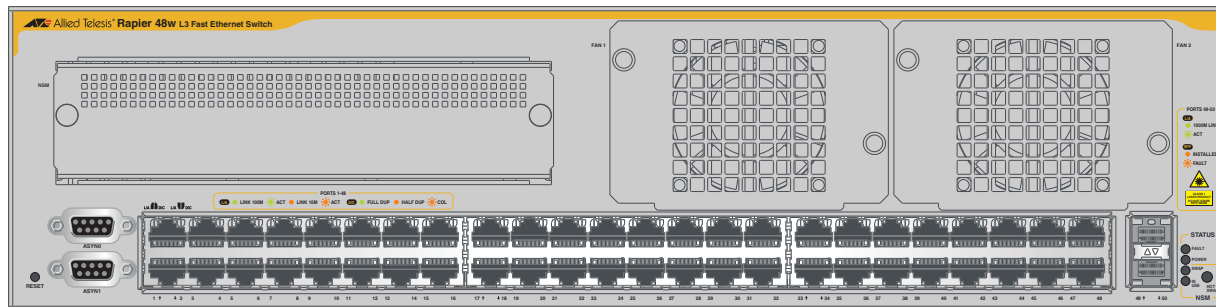
Rapier 48w front panel

- 48-port 10BASE-T/100BASE-TX (RJ-45 connectors)
- Two 1000BASE SFP ports
- Two asynchronous serial console ports with DB9 connectors
- One Network Service Module bay, with support for various WAN interface cards
- Auto-negotiating Layer 3 Managed Switch
- Enhanced switching core
- Replaceable air filters and fan-only modules (FOMs) for NEBS applications

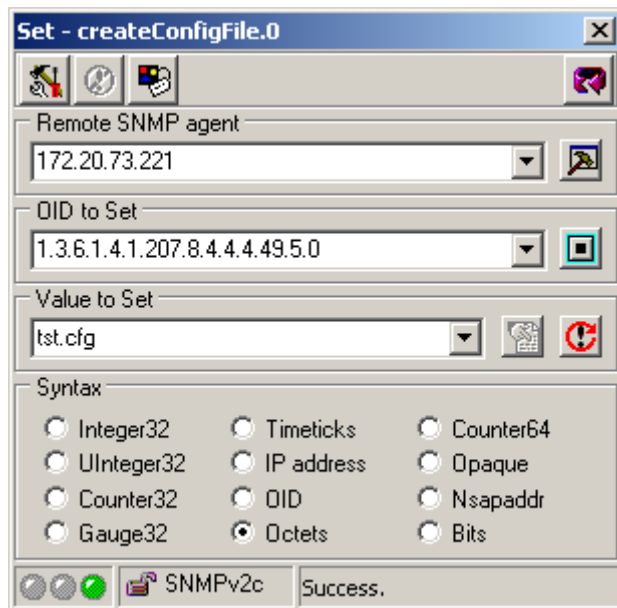
1. Save the configuration

To save the current configuration, use SNMP SET createConfigFile. The following screenshot shows this for a file called tst.cfg.

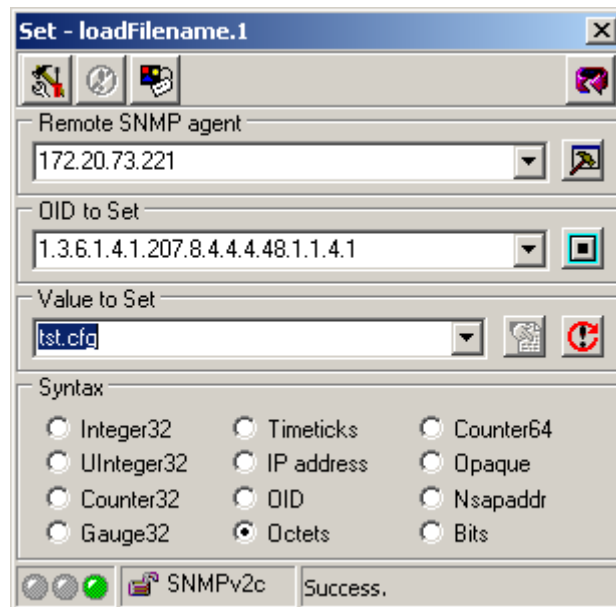
2. Set the load parameters

To specify the server IP address, use SNMP SET loadServer. To set the filename, use SNMP SET loadFilename. The following screenshot shows setting the filename to tst.cfg.

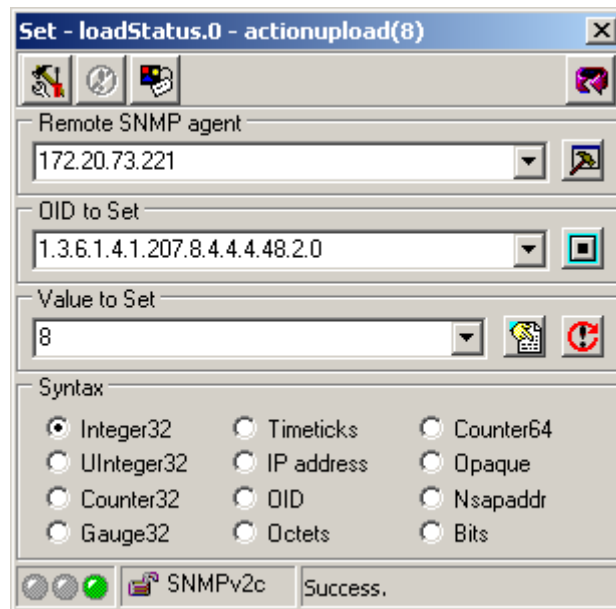
3. Upload the file

To upload the file, use SNMP SET loadStatus and set it to a value of 8. The following screenshot shows this.
